Hayden Lake Water Quality Report – 2006

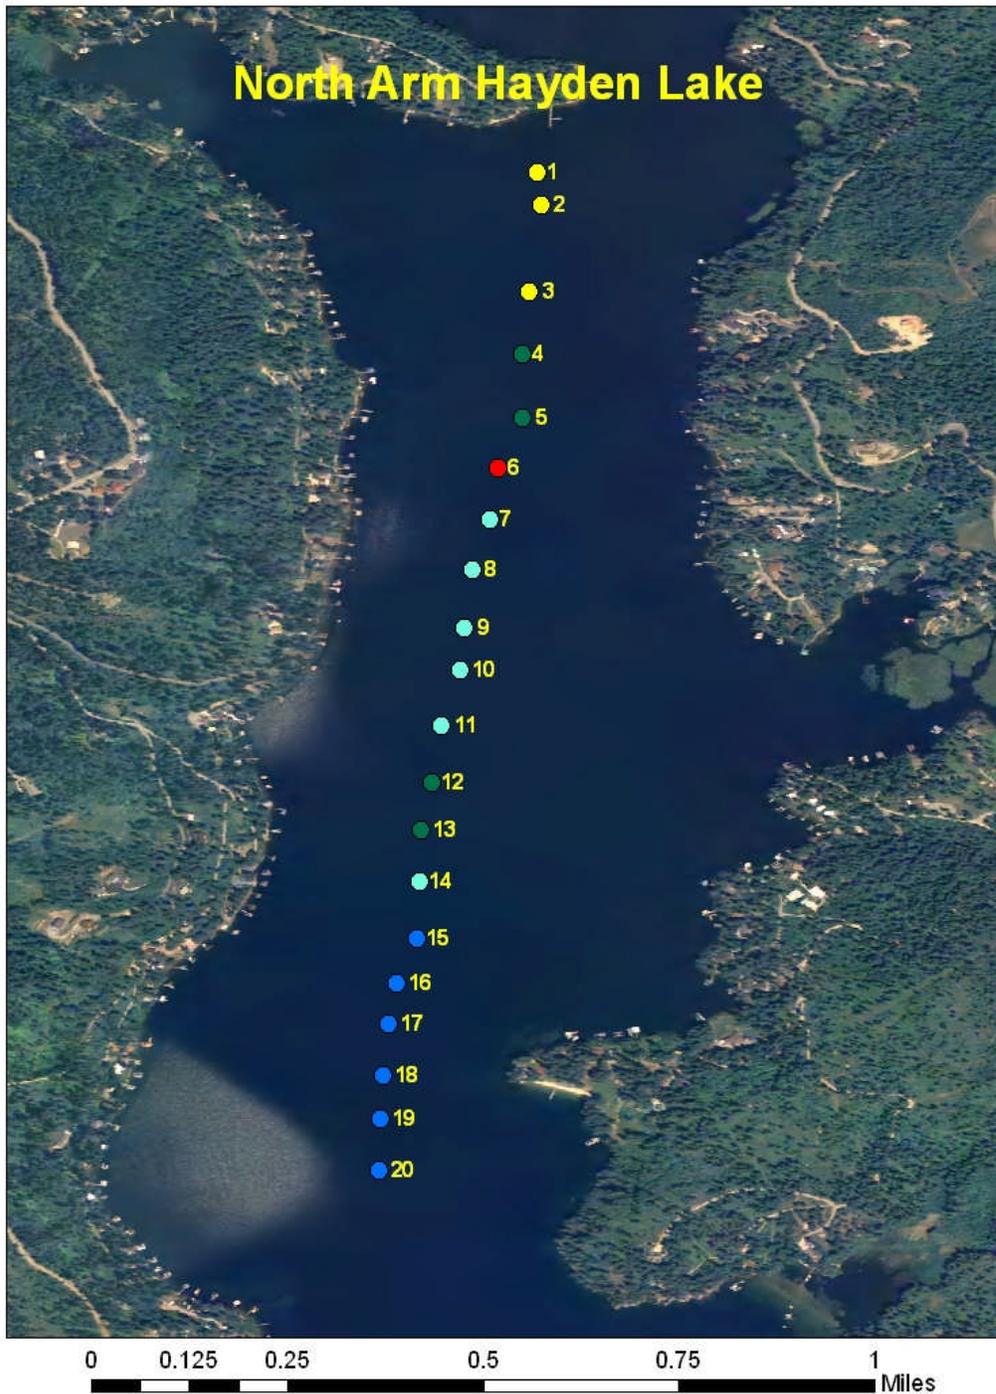
Figure 5: Chlorophyll fluorescence of the water column at individual locations on a transect between the Sportsman's Access Bay and mid-lake area off Chicken Point.

During late August and September, the water column of the lake is stratified between warm water on the surface and cold water at depth. During this period precipitation is at a minimum and for this reason, discharge into the lake is at a low point. Weather is typically warm, calm and stable. The result of these conditions is a stable water column in the lake, allowing the most repeatable results from year to year as possible. During this period (September 14th), transects were made from near Sportsman's Access down the northern arm to the mid-lake area off Chicken Point, from Berven Bay to the mid-lake area off Berven Bay, and from Windy Bay to the mid-lake area off Windy Point. Along these transects, the relative fluorescence of chlorophyll was measured in real time and the data was linked to the global position at which it was collected. It is expected that chlorophyll concentration, as measured as its fluorescence property will increase in more nutrient rich areas of the lake. A gradient of chlorophyll florescence was found as expected across the northern arm of Hayden Lake (Figure 5). Points in red and yellow have the highest fluorescence signal, while those in green and light blue have a moderate signal and those in dark blue the lowest signal and therefore the lowest relative chlorophyll concentrations. Only low chlorophyll florescence signals (blue) were detected through the Berven and Windy Bays transects.

Water quality station data are not the most sensitive indicator of changes occurring in the lake water quality. Since bays, and especially the Northern Arm of Hayden Lake that was a marsh prior to construction of the outlet dike, have higher algae growth (Figure 5), a change in the level of algae growth along the transect from the mid-lake area towards Sportsman's Access will be a sensitive indicator of the improvement or decline of lake water quality. A second year of relative algae growth data collection (chlorophyll fluorescence) in real time and at known global position was completed. These data have not been fully processed for interpretation. Additional collection of these data will be required in successive years to scientifically assess any change in water quality status.
